# The use of spunbonded geotextile in railway track renewal St. Petersburg-Moscow

E.S. ASHPIZ, University of Transport Engineers, Moscow, Russia R. DIEDERICH & C. KOSLOWSKI, DuPont de Nemours, Luxembourg

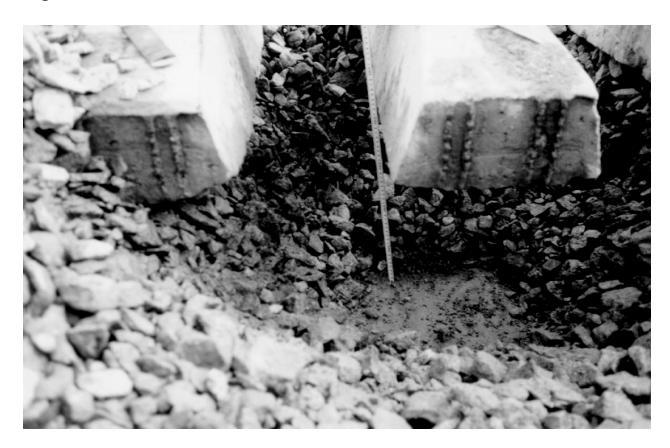
Figure 3. Excavation from under the track

After 5 years of service life the track was opened on several sections in order to determine the performance of the geotextile. Samples were excavated and tested to determine area weight, breaking load and water permeability.

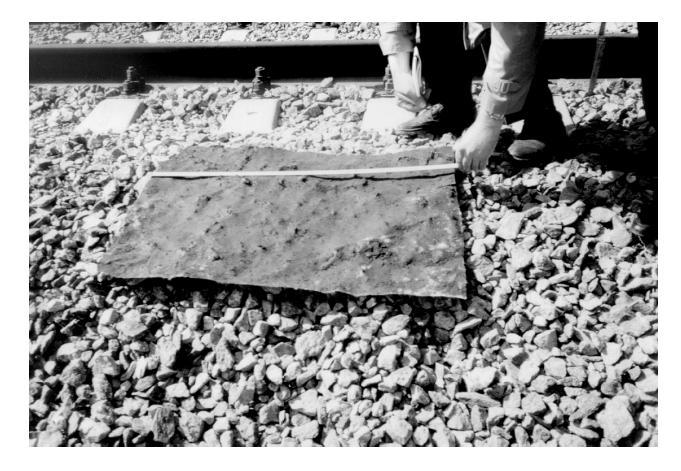
#### Figure 4. Excavated sample of geotextile with some old ballast

After 5 years of service life the total damage surface was 0.3 % compared to 0.2 % after one year. The retained strength after one year was 74 % and after 5 years still 72 % with a remaining elongation of up to 30%.

Some contamination of the geotextiles was noticed after extraction. Tests of the un-cleaned geotextile with ballast showed that the water permeability of the whole structure decreased only 1.5 times. The conditions found on the track at various sections confirmed that the existing decrease in water permeability of the geotextile did not affect humidity conditions of the structure as most part of incoming water is drained in the ballast layer on top of the geotextile. During extraction it was found that the moisture content of the ballast under the geotextile was 1-2% less than above the geotextile.

It was clearly visible that the contamination was mainly coming from the top of the structure due to abrasion of ballast and rain falls. Only minor contamination was found on the bottom part of the geotextile.

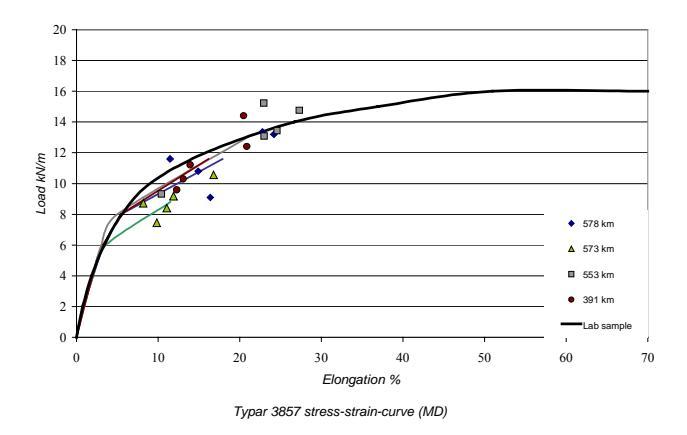
Figure 5. Typar® 3857 stress-strain-curve (MD)

Figures 5 and 6 show the stress-strain curves of the geotextile after 5 years at different locations compared to the initial results. The tensile strength test was performed on 5cm wide samples. The geotextile showed no decrease in puncture strength. Puncture strength after 5 years of service life was 1281 N compared to 1280 N of initial strength.
